2013  
STATE OF  
THE  
WATERSHED

NINE MILE RUN  
WATERSHED ASSOCIATION

Every two years, NMRWA presents a summary of ongoing scientific research conducted on the Nine Mile Run Aquatic Ecosystem Restoration - the State of the Watershed Report. This 2013 report is the 4th biennial report - three previous reports were published in 2007, 2009, and 2011.

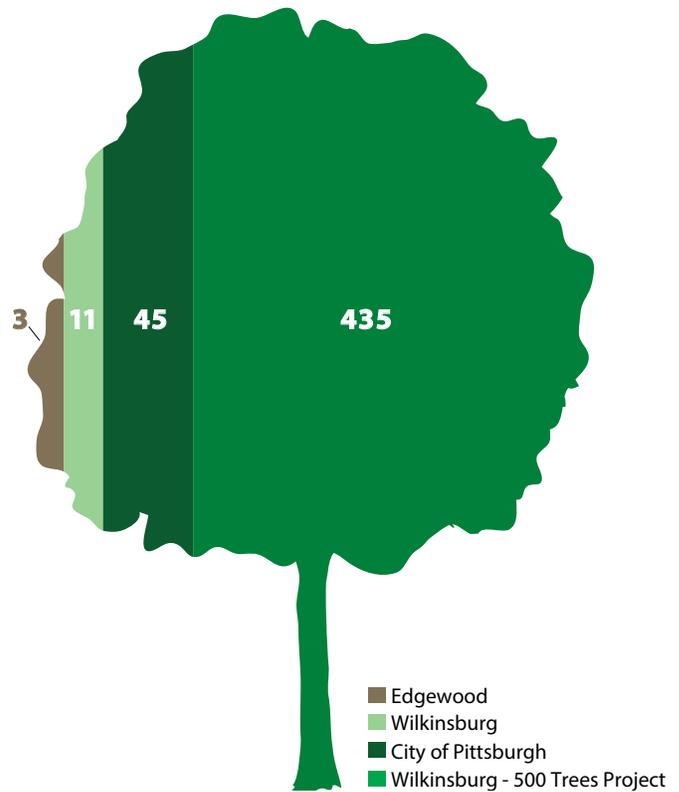
**Figure 6.** NMRWA planted 494 trees in the watershed during 2011 & 2012, the majority of which were planted in Wilkinsburg as a part of the Wilkinsburg TreeVitalize Project.

The majority of trees planted in 2011 and 2012 were a part of NMRWA's Wilkinsburg TreeVitalize Project: Rooted in Wilkinsburg – 500 Tree Initiative. Beginning in Fall 2011, the goal of the project was to plant 500 street trees in Wilkinsburg over a two year period. Funding for this project was received through the Pennsylvania Infrastructure Investment Authority, and NMRWA's project partners were TreeVitalize, the Borough of Wilkinsburg, and the Wilkinsburg Community Development Corporation.
